Roof Repair Analysis Report

Customer	Insurance Co.	Control Number	H3M1234567
Date Received	2/9/2022	Date Invoiced	2/9/2022
Adjuster	Jane Adjuster	Customer ID	INS0001

Claim Number	12345678910	Loss Date	1/30/2022
Insured Name	John Homeowner	Area Damaged	REAR SLOPE
City,State,Zip	Anytown, TX 12344

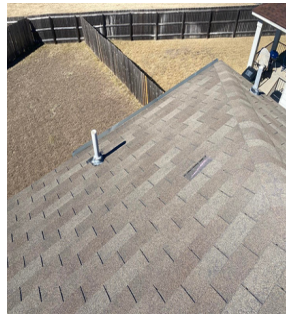
Slope 1 Overview #1

Area	Determination	Analyst Observation
Slope 1	Repair	<ul style="list-style-type: none">• <i>Light Granule loss</i>• <i>Ridge cap damage does not affect adjacent slope(s)</i>• <i>Missing tabs/shingles</i>
Slope 2	Repair	<ul style="list-style-type: none">• <i>Ridge cap damage does not affect adjacent slope(s)</i>• <i>Peeled back shingles</i>
