Roof Repair Analysis Report

Claim Number	12345678910	Loss Date	1/30/2022
Insured Name	John Homeowner	Area Damaged	REAR SLOPE
City,State,Zip	Anytown, TX 12344

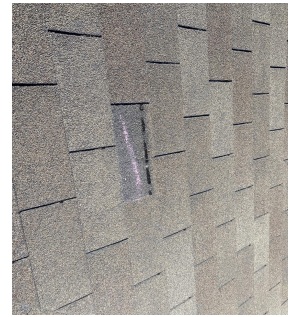
Slope 1 Close Up #1

Area	Determination	Analyst Observation
Slope 1	Repair	<ul style="list-style-type: none">• Light Granule loss• Ridge cap damage does not affect adjacent slope(s)• Missing tabs/shingles
Slope 2	Repair	<ul style="list-style-type: none">• Ridge cap damage does not affect adjacent slope(s)• Peeled back shingles
